**Docket No. 217 – Development and Management Plan Inspection**

Northeast Utilities Service Company Certificate of Environmental Compatibility and Public Need for the construction of a 345-kV electric transmission line and reconstruction of an existing 115-kV electric transmission line between Connecticut Light and Power Company's Plumtree Substation in Bethel, through the towns of Redding, Weston, and Wilton, and to the Norwalk Substation in Norwalk, Connecticut.

**Date:** November 17, 2005

**Location:** Norwalk Substation Expansion

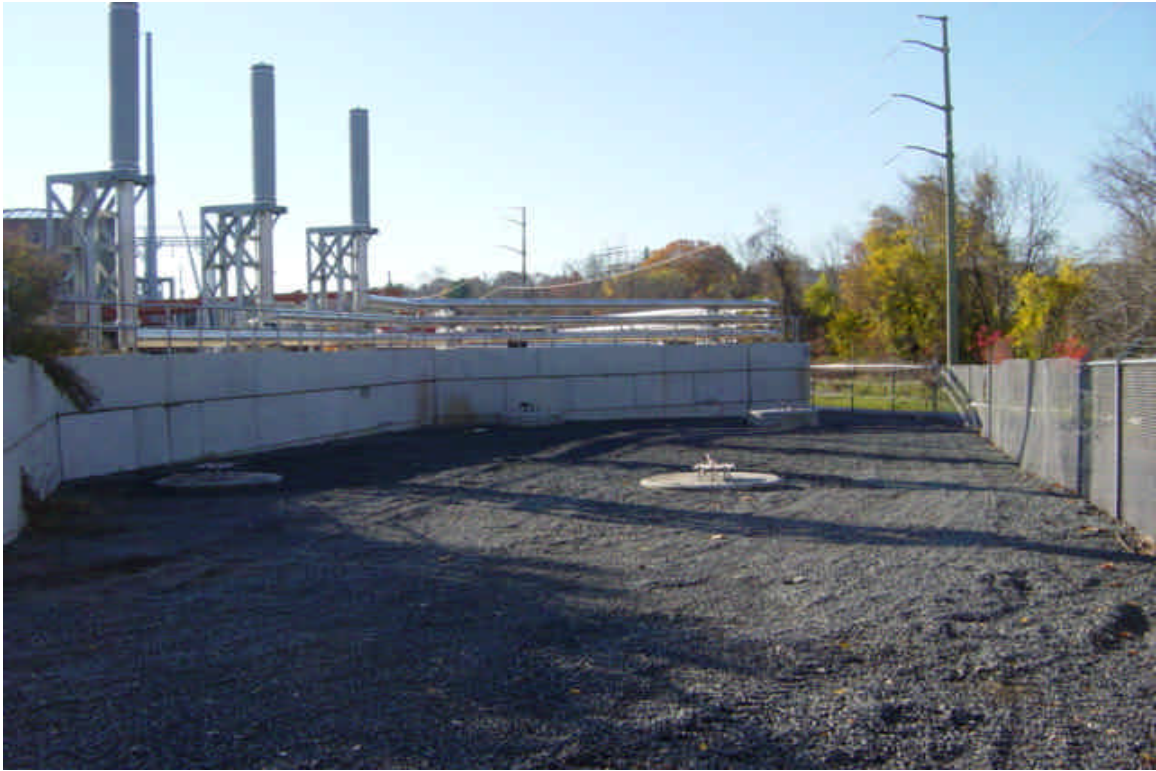
**Norwalk Substation: View of the foundations for structures where work was observed last week. 11/17/05**

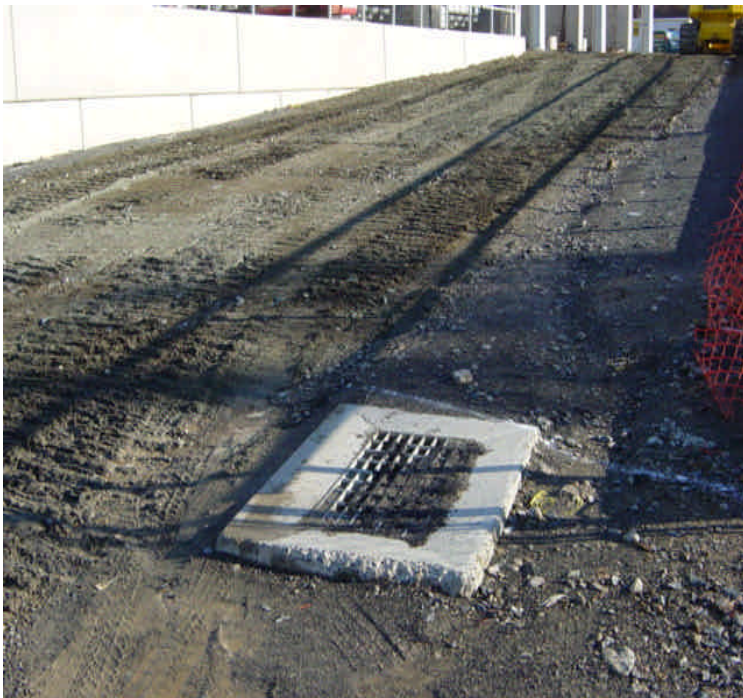
Areas of Inspection	Observation	Recommended Action
Erosion and Sediment Controls	- The catch basin at the southwest corner of the GIS building has some observable sediment accumulation	- The catch basin is going to be cleaned out and a new silt sak will be installed. 11/17/05
Erosion and Sediment Controls continued (includes inspection within 24 hours of a storm event)	<p>as the original protective fabric here is wearing out. 10/27/05-11/17/05.</p> <p>- Sedimentation from the access road off the Rt. 7 ramp was noted in the vegetated perimeter swale but it did not leave the site. 9/21/05-11/17/05.</p> <p>-The overflow channel had some accumulated sediment at the edge of the river due to the flooding and potentially the adjacent fill work. 10/27/05-11/17/05.</p> <p>- The work at the turning structure is now completed and some bare soil remains in the area. . 11/10-11/17/05.</p> <p>- Silt fence had been removed from along the bike path as the area around the new foundations was placed with stone and restored. 11/17/05</p> <p>- A number of stockpiles are noted in the yard near the GIS building but they are all well contained. 11/17/05</p>	<p>- Sedimentation and gravel remain contained within the swale. The access road will be paved eventually which will remove the problem. Continue to monitor area until final stabilization. 9/21/05-11/17/05.</p> <p>- Sediment may need to be removed by hand here in order to restore the original capacity of the channel. 10/27/05-11/17/05.</p> <p>- It should be confirmed the channel is at original grades and the disturbed surfaces should be mulched at least as re-vegetation will not occur at this time. 11/10-11/17/05.</p> <p>- None at this time. 11/17/05</p> <p>- All piles are well within the site. None at this time. 11/17/05</p>

**Photo on the left shows the catch basin near the southwest corner of the GIS building that will be cleaned out and fitted with a silt sack. Photo on the right shows the inlet at the Rt 7 ramp where silt fence can be removed as stone is in place. This area receives a lot of off-site stormwater. 11/17/05.**

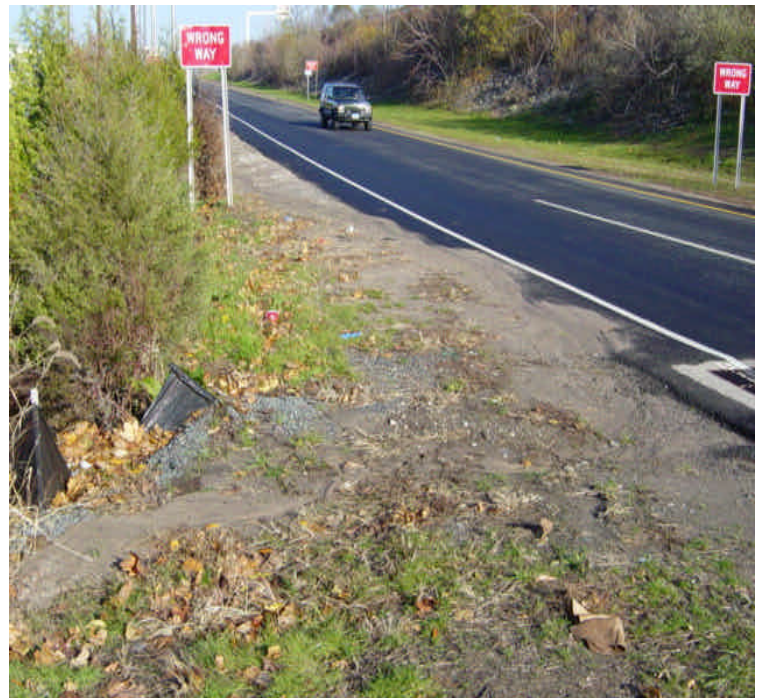
Areas of Inspection	Observation	Recommended Action
Access Roads and Adjacent Roadways	- The inlet near the Route 7 ramp receives a lot of off-site stormwater and sediment accumulation was noted here. Silt fence is partially collapsed here but the surrounding stone also helps to filter. 11/17/05.	-The area should continue to be monitored to some degree but sediment is being filtered well by the stone and vegetation. The silt fence could be removed as stormwater volumes are from off site . 11/10/05.
Foundation construction	<p>-Work continues on structures accessed from the western side of the GIS building and a number of stockpiles remain in the adjacent yard area. 11/17/05.</p> <p>- The two new foundations were in place at the northwest portion of the site between the retaining wall and the bike path. 11/10-11/17/05</p> <p>-Clean up activities associated with the 345 kV Turning Structure work appear to be completed with materials removed and the area regraded. 11/10-11/17/05.</p>	<p>- This excavation and backfill work is well within the yard and areas are contained. 11/17/05.</p> <p>-None at this time. The area has been restored and structures will be installed. 11/17/05</p> <p>-It should be confirmed that all grades were met as proposed and temporarily disturbed areas are back to their original grades. 11/10-11/17/05.</p>

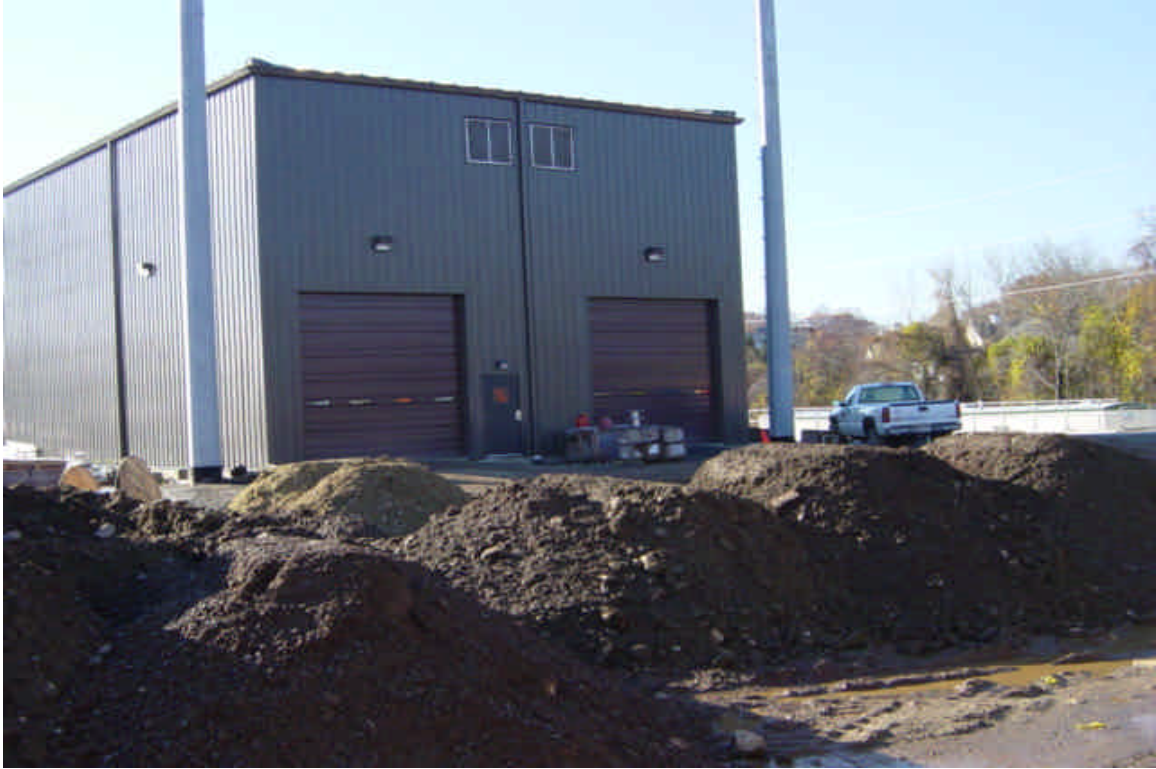
View of the stockpiles placed near the GIS buildings. All soil remains contained on site  
11/17/05.

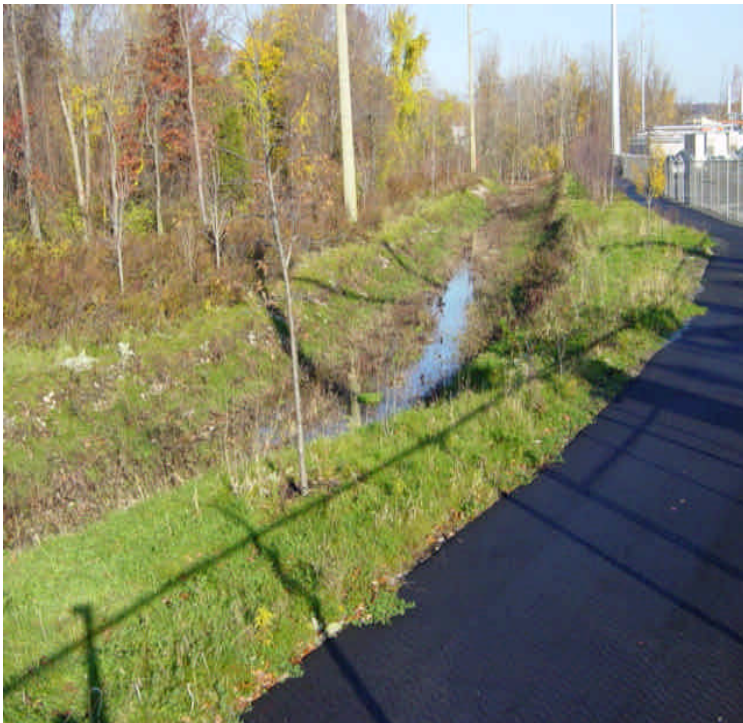
Inland Wetland and Watercourse encroachment and mitigation	<p>-The 345kV work area appears to have been restored but could use some mulch for temporary stabilization. 11/10-11/17/05</p> <p>-Sediment was noticed at the edge of the overflow channel and the river. 11/02-11/17/05.</p>	<p>- Mulch bare soil areas until vegetation can be established after the winter. 11/10-11/17/05</p> <p>- Continue to remove any loose sediment due to the project in the channel and work area. 11/17/05.</p>
State species of concern, threatened and endangered species	- No species of concern are located in this area of construction.	- N/A

Photo on the left shows a view of the overflow channel and adjacent bike path. Photo on the right shows a view of Plumtree Substation where work internal to the pad continues.  
11/17/05.
